Analysis of Impactor Residues in Tray Clamps from the Long Duration Exposure Facility

Part 2: Clamps from Bay "B" of the Satellite

Ronald P. Bernhard
Michael E. Zolensky

NASA Technical Memorandum 104784

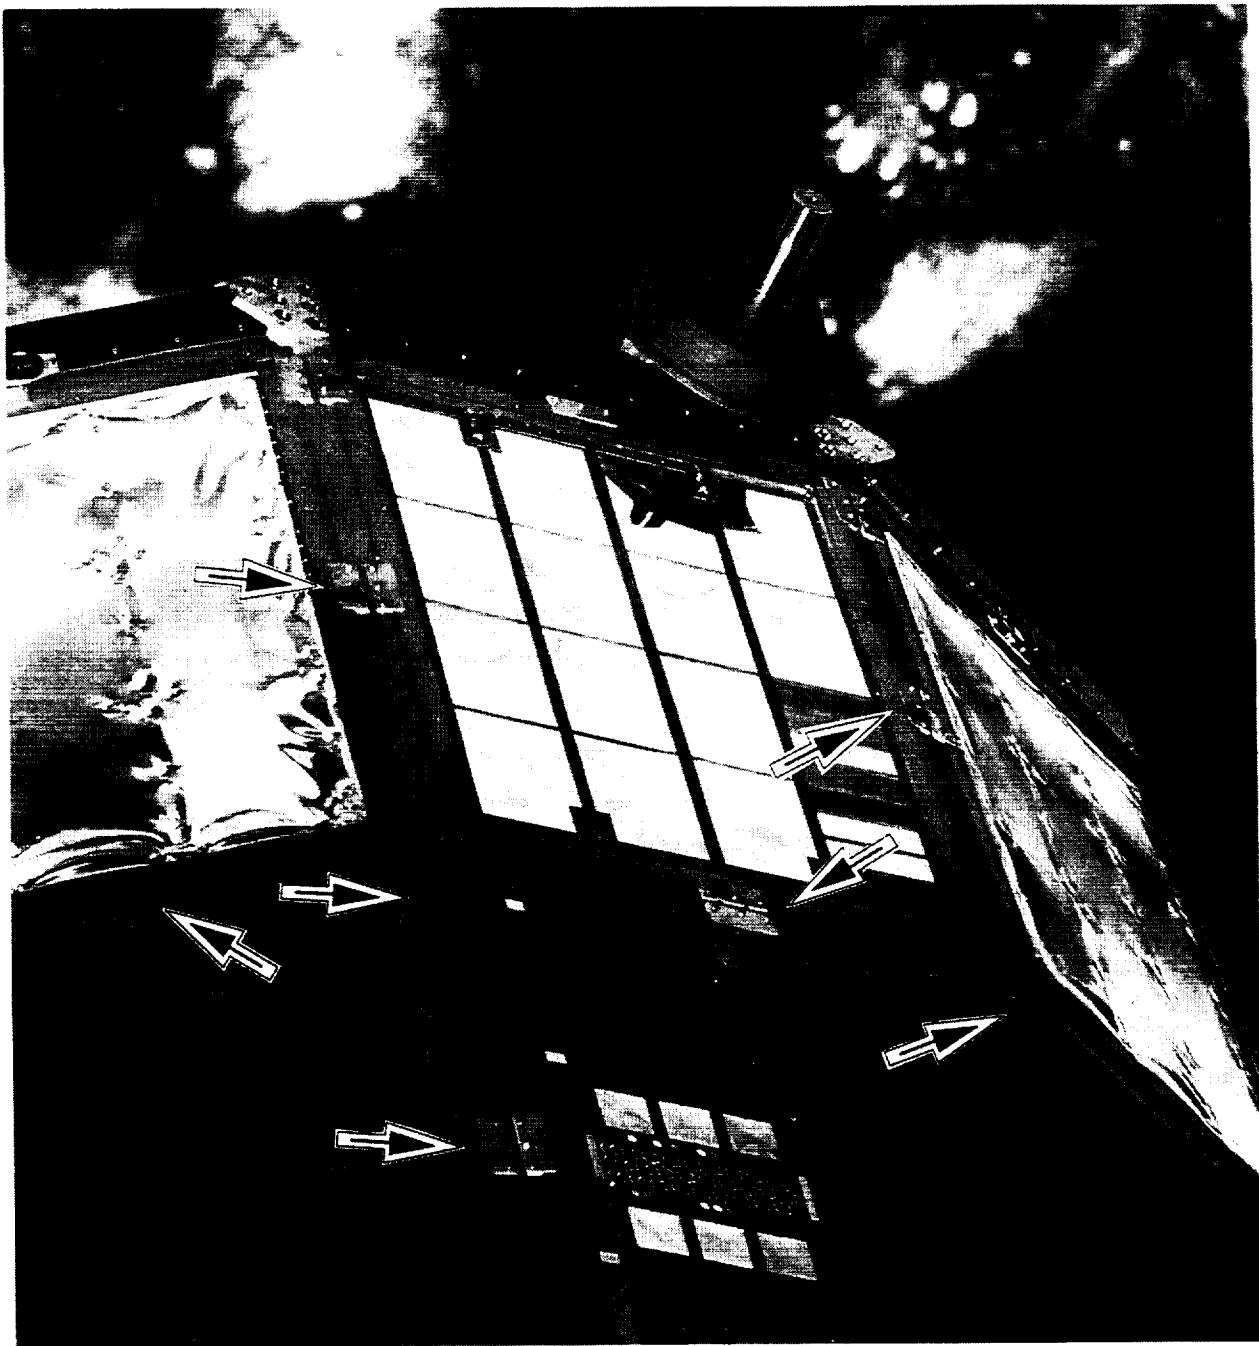
FIGURE 1. A photograph taken of the trailing/Earth edge of the Long Duration Exposure Facility (A03) during the STS-32 retrieval mission. The arrows placed on the photograph show the location of clamps used to hold experiment trays in place during their exposure in low Earth orbit. The circles or round patches on some of the clamps are test paint coupons. Several possess impact craters but, because of surface contamination impact residues, these were not characterized here.

All LDEF experiment trays were held in place by a series of aluminum clamps (fig. 1). Each clamp had an exposed area of approximately 58 cm². One-half of the LDEF tray clamps have been archived at the NASA/Johnson Space Center (JSC) by the Meteoroid & Debris Special Investigation Group (M&D SIG). These archives are available for study by qualified investigators. For more information regarding these materials, contact the JSC Curatorial Facility. The remaining half of the clamps are being studied by the LDEF Materials Space Investigation Group.

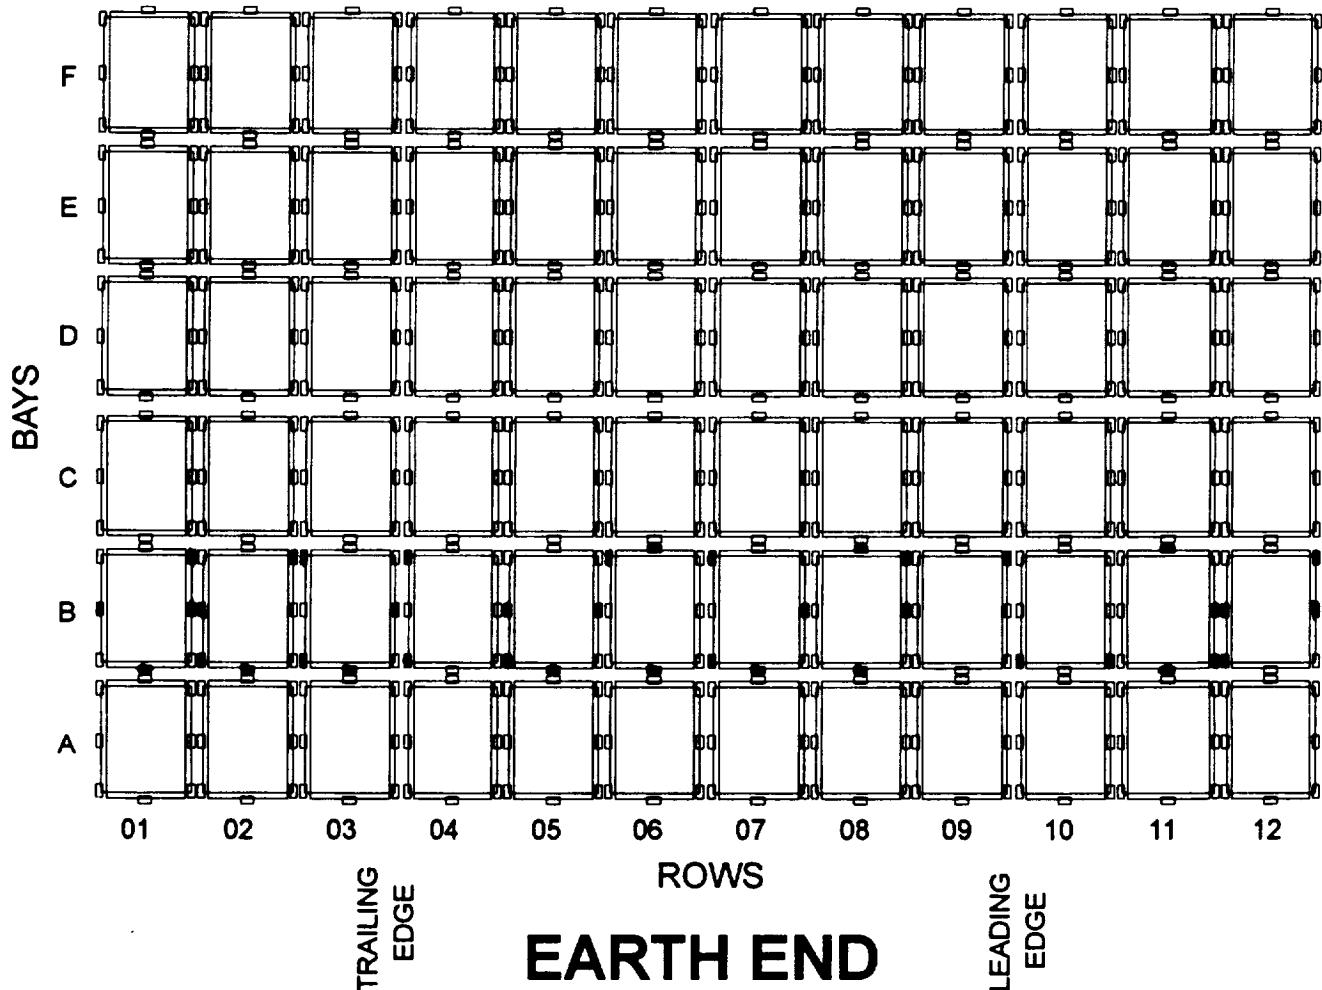
FIGURE 2. This diagram illustrates the numbering scheme used to label LDEF experiments by Bay and Row location. LDEF was a cylinder-shaped satellite with Row 1 being adjacent to Row 12, Bay A being on the Earth end, and Bay F positioned on the space facing end. While in orbit, Row 9 was in the ram direction or the leading edge, with Row 3 being on the trailing edge of motion. Clamps examined for this report are designated by dark fill.

LDEF experiment trays were held in place by a series of chromic-anodized aluminum (6061-T6) clamps (fig. 2). Eight clamps were used to attach the experiment trays on each of the 12 sides of the LDEF, while experiment trays on the Earth and space ends were held in place by 12 clamps. Each clamp was fastened to the spacecraft frame using three stainless-steel hex bolts. Clamps exposed an area of approximately 58 cm² each (4.8 cm × 12.7 cm × 0.45 cm, minus the bolt coverage). All 774 LDEF clamps were surveyed for impact features greater than 0.5 mm in diameter during experiment tray deintegration at the NASA/Kennedy Space Center. Some 337 out of 774 LDEF tray clamps have been archived by the M&D SIG in the Curatorial Facility at JSC and are available for scientific examination by qualified individuals.

A clamp numbering scheme was devised that would provide hardware location information with respect to its position within a particular bay (fig. 2). From the labeling scheme, it can be seen that a clamp occupying position 1 of Bay A02 would be identified by the label A02-C01, with A02 indicating the experiment location of Bay "A" and Row "02", and with C01 interpreted as "C" for the clamp and "01" being the clamp number. Each clamp uses a Cartesian coordinate system to reference impact locations on exposed surfaces. The X and Y coordinates were measured in millimeters using a standard origin assigned by the M&D SIG at the lower left corner of each clamp (fig. 3).

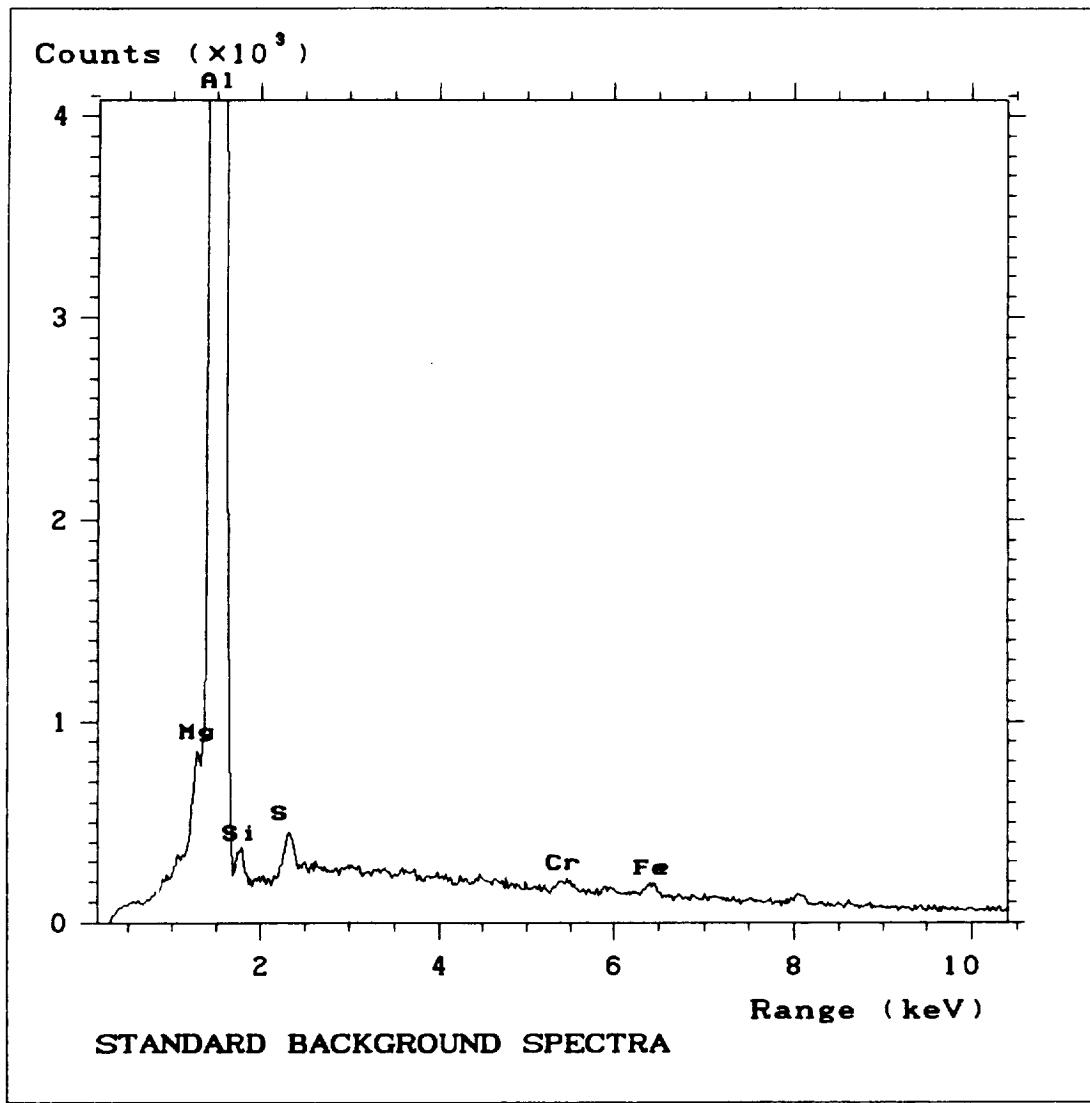
FIGURE 8. Many of the impacts analyzed by SEM/EDXA had no residue detected. These impact features are categorized as being unknown in origin. During analysis, no peaks above background were discernible; only the typical clamp materials were present. This spectra illustrates the typical composition of impacts with no detectable residue found.

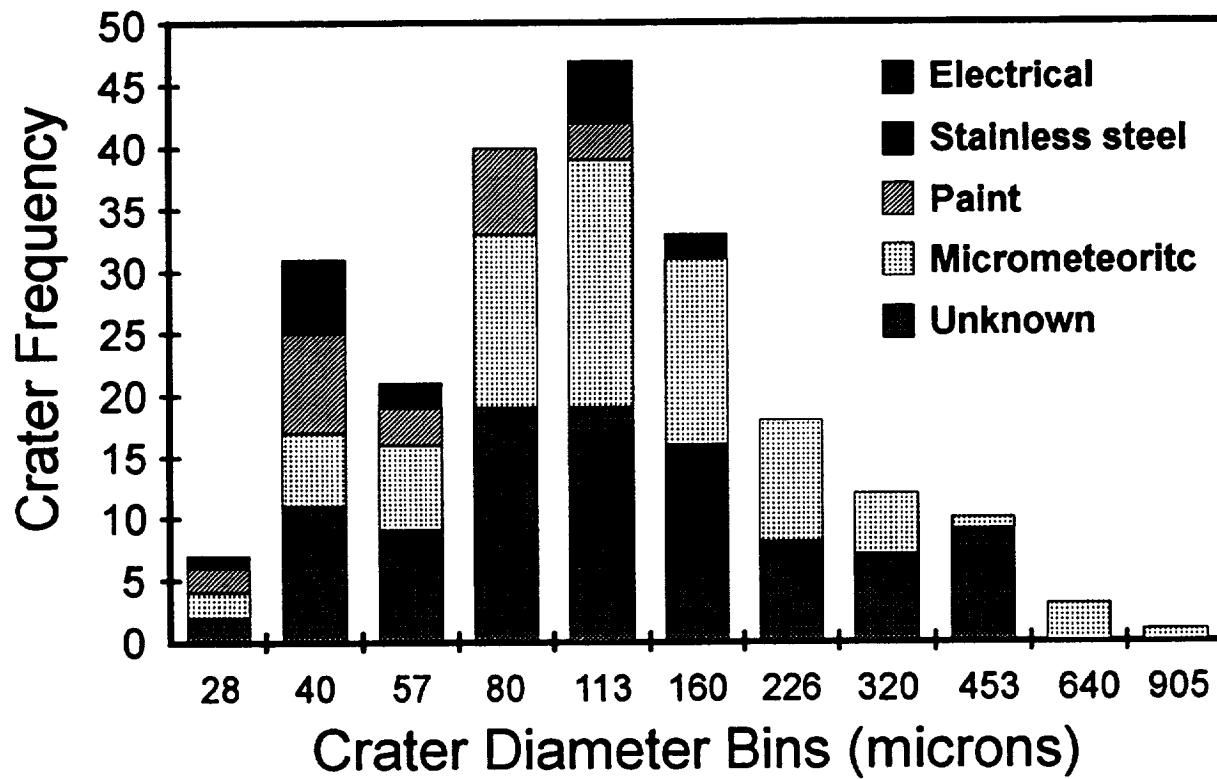
TRAY CLAMP IMPACTS

FIGURE 9. Histogram illustrating the determined impactor type versus the impact crater diameter. Samples listed as being contaminated contain significant amounts of foreign material and projectile remnants that are not easily identified.

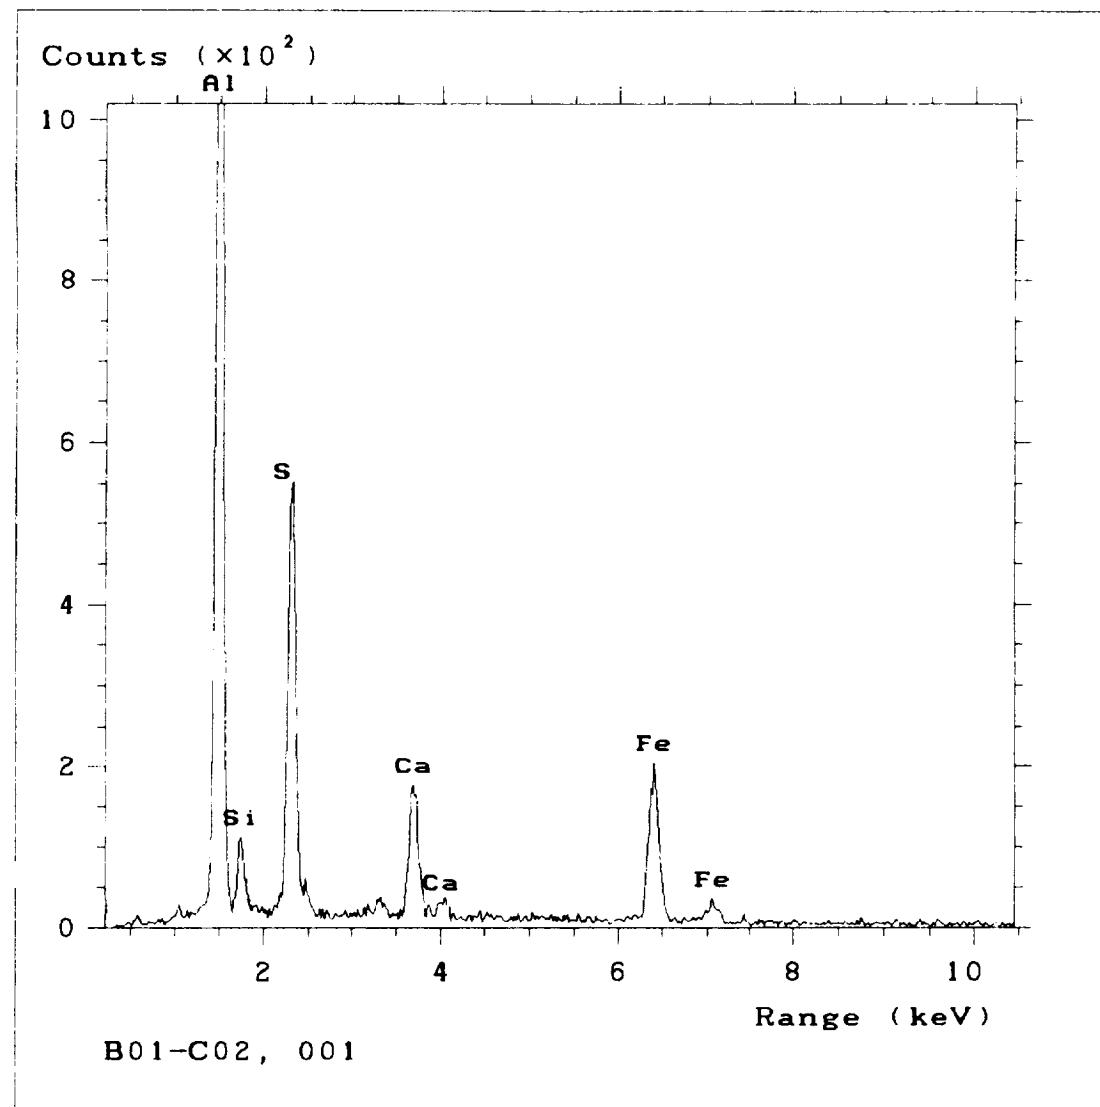
CLAMP NO.	IMPACT NO.	XCoor (mm)	YCoor (mm)	DIAMETER (μm)	COMMENTS (origin)
B01-C02	001	16	26	220	MICROMETEORITIC
	002	98	36	120	PAINT PATCH
	003	43	40	100	MICROMETEORITIC

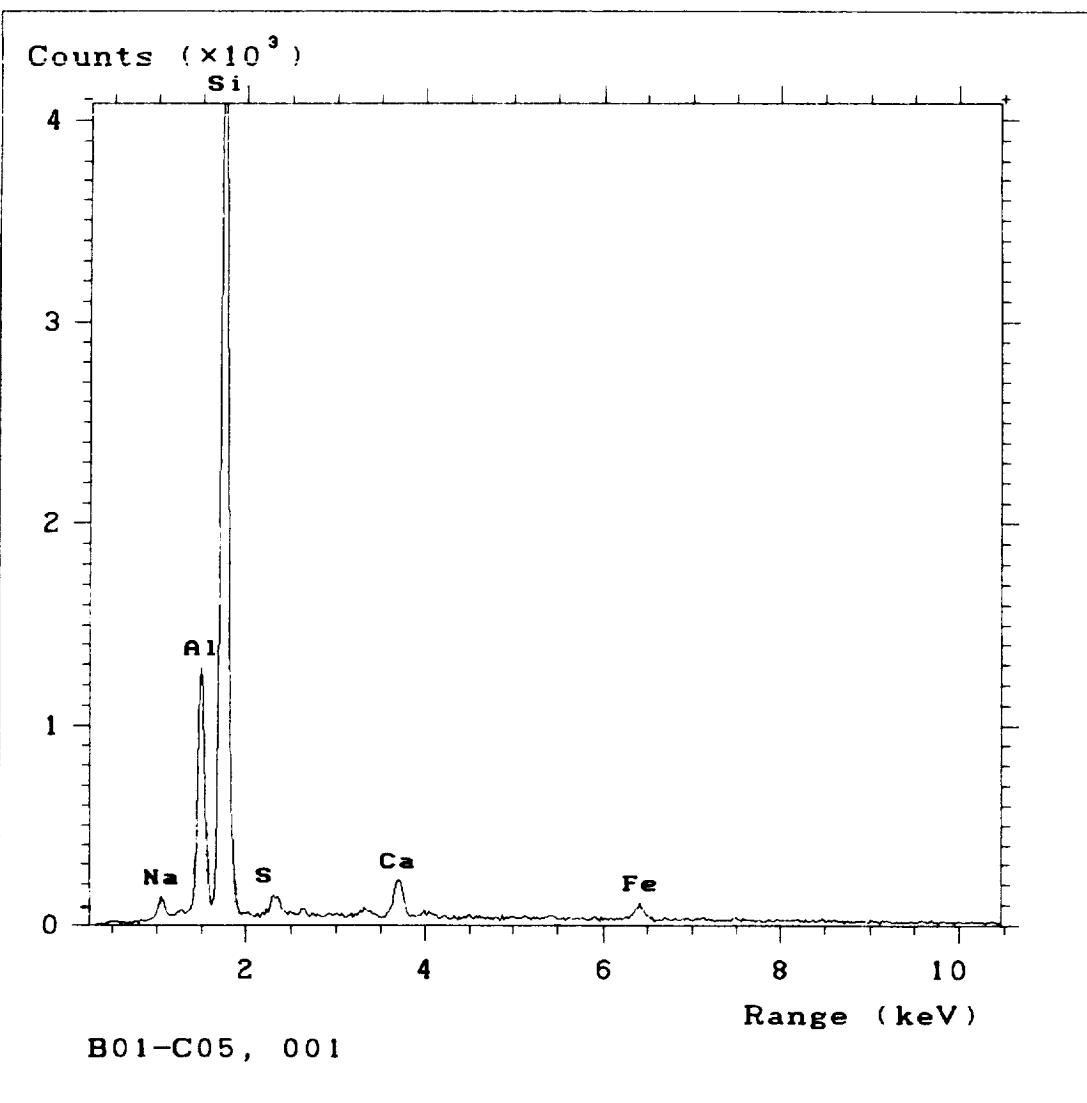
<u>CLAMP NO.</u>	<u>IMPACT NO.</u>	<u>XCoor (mm)</u>	<u>YCoor (mm)</u>	<u>DIAMETER (μm)</u>	<u>COMMENTS (origin)</u>
B01-C05	001	93	2	100	MICROMETEORITIC

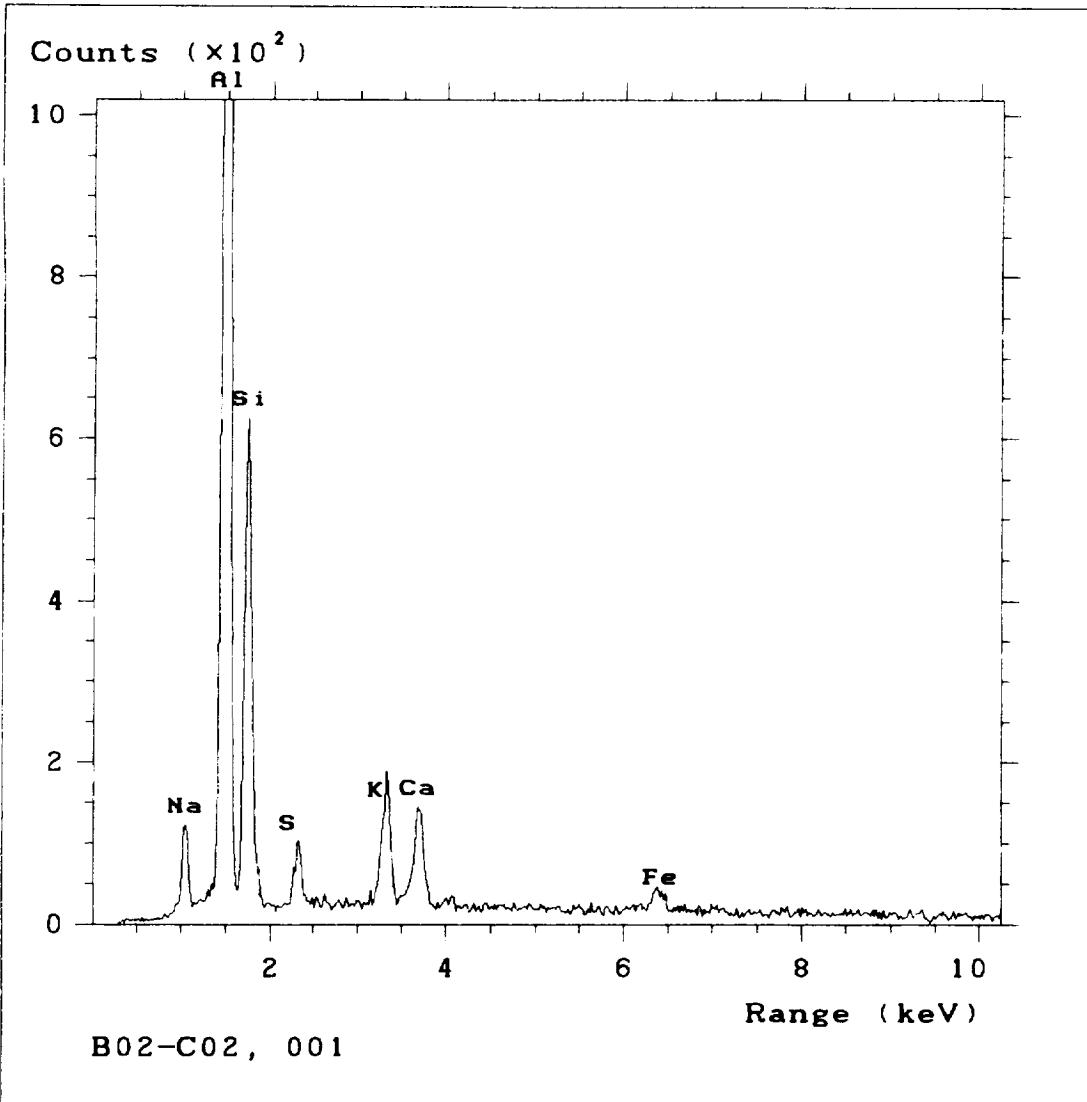
CLAMP NO.	IMPACT NO.	XCoor (mm)	YCoor (mm)	DIAMETER (μm)	COMMENTS (origin)
B02-C02	001	65	28	270	MICROMETEORITIC

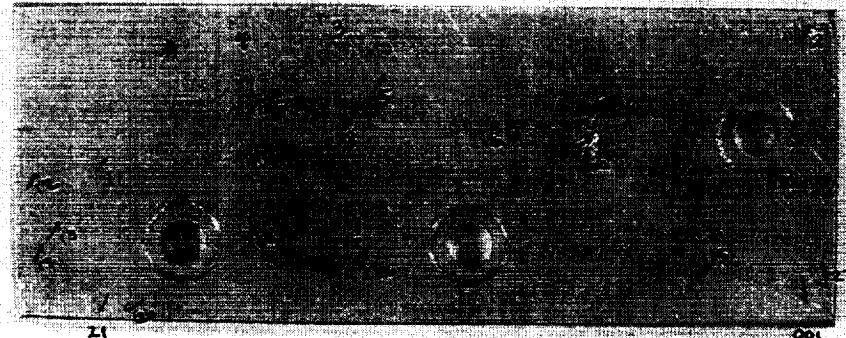
B10 - C01

CLAMP NO.	IMPACT NO.	XCoor (mm)	YCoor (mm)	DIAMETER (μm)	COMMENTS (origin)
B10-C01	001	4	46	700	MICROMETEORITIC
	002	4	2	10	PAINT
	003	77	1	130	UNKNOWN
	004	91	3	40	UNKNOWN
	005	70	10	50	UNKNOWN
	006	52	17	12	UNKNOWN
	007	86	12	80	UNKNOWN
	008	75	17	110	UNKNOWN
	009	39	20	200	MICROMETEORITIC
	010	39	19	30	MICROMETEORITIC
	011	112	23	30	NOT AN IMPACT
	012	123	25	60	MICROMETEORITIC
	013	119	32	50	UNKNOWN
	014	34	34	70	MICROMETEORITIC
	015	20	39	40	ELECTRICAL
	016	71	40	110	MICROMETEORITIC
	017	73	39	50	MICROMETEORITIC
	018	91	36	230	UNKNOWN
	019	123	36	150	UNKNOWN
	020	111	46	50	STAINLESS STEEL
	021	114	46	30	NOT AN IMPACT
	022	1	43	130	UNKNOWN

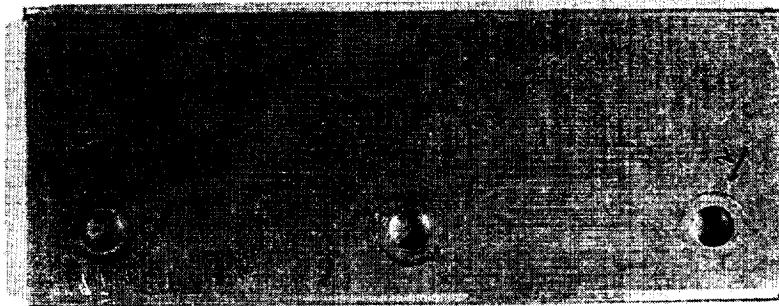
CLAMP NO.	IMPACT NO.	XCoor (mm)	YCoor (mm)	DIAMETER (μm)	COMMENTS (origin)
B11-C08	001	2	77	200	MICROMETEORITIC
	002	18	10	500	UNKNOWN
	003	21	74	220	UNKNOWN
	004	24	79	70	MICROMETEORITIC
	005	22	84	160	MICROMETEORITIC
	006	44	99	150	MICROMETEORITIC
	007	24	120	30	PAINT
	008	25	109	30	ELECTRICAL

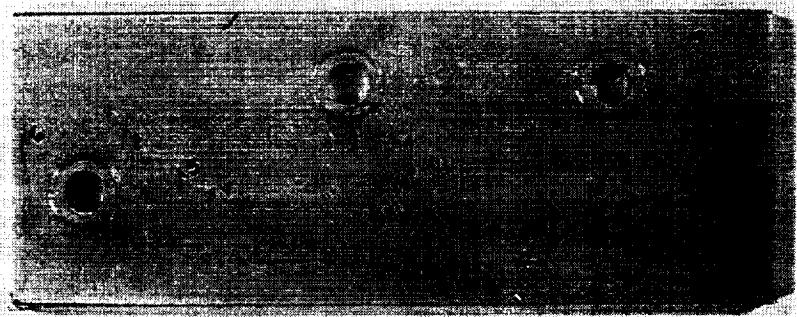
CLAMP NO.	IMPACT NO.	XCoor (mm)	YCoor (mm)	DIAMETER (μm)	COMMENTS (origin)
B12-C01	001	96	21	600	UNKNOWN
	002	89	9	170	UNKNOWN
	003	96	1	200	UNKNOWN
	004	32	19	130	UNKNOWN
	005	27	22	370	UNKNOWN
	006	2	28	21	UNKNOWN
	007	19	29	60	PAINT
	008	127	39	150	EDGE
	009	117	40	140	UNKNOWN
